Cheapside House, London

Case Study

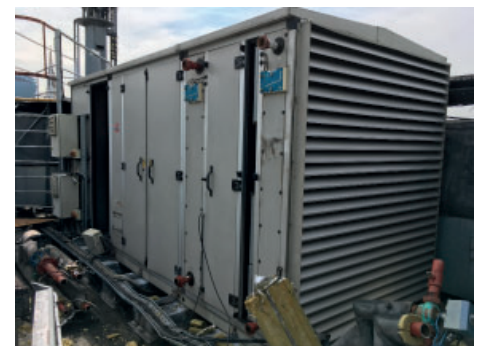
The air handling units (AHUs) at Cheapside House were installed several years ago by another manufacturer and were showing signs of ageing; energy consumption was high and performance was compromised. GDM approached Barkell AHU specialists for their advice on how to remedy this issue. The first task was for Barkell to attend site to do a complete survey of the project, identify any obstacles and present a project plan. The main obstacles identified by Barkell engineers were that the existing AHU were situated on a roof top in Central London, with limited access. The only way to get anything on to the rooftop was by using a small hoist and this presented its own health and safety challenges.

Image above shows original AHU before refurbishment works were completed.

Replacing the full unit would be costly and logistically challenging and more importantly, unnecessary. A full refurbishment was identified as the solution and as such a costed proposal was put forward to GDM that allowed the fans, filters, access panels, heating coil, isolators, internal boxing and doors to be upgraded, part by part. This method of refurbishment would allow for smaller parts to be delivered to the roof top via the available means, negating the requirement to remove and replace the full unit.
